THE GEOMORPHOLOGICAL EVALUATION OF THE PROTECTION STRUCTURE OF ALEXANDRIA BEACHES BETWEEN SHATBY- MONTAZAH AREA

Dr. Naglaa Oref

Lecturer of Physical Geography and remote sensing
The Higher Institute of Arts Studies ' King Maryot
Alexandria, Egypt

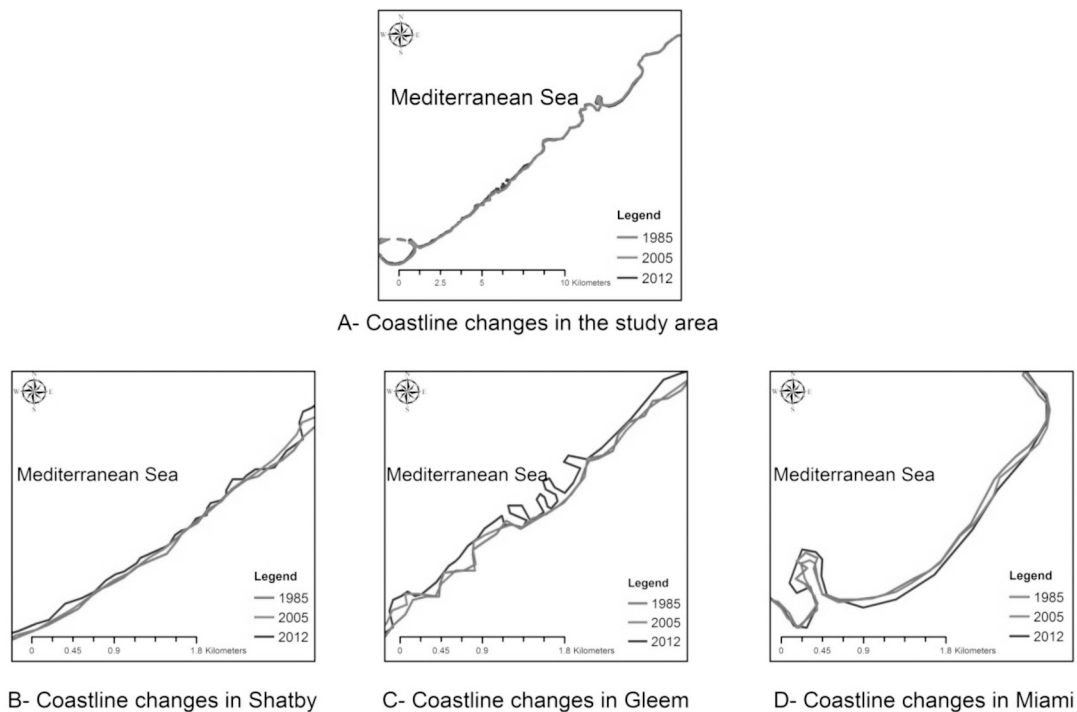
Figure 1. (A) Monitoring the coastline changes during the period between (1985 -2012) in the whole study area.

Consequent of the above factors changes in the coastline; we can recognize it in the study area. Figure 1. And table 1, which describe the coastline changes during the period between (1985 -2012). The coastline wrap rate doesn't show a big difference in the study area, we can recognize a slight increase in 2012, because of the protective structures are started in 2006.

(B) Monitoring the coastline changes in Shatby during the same period,

(C) Monitoring the coastline changes in Gleem.

(D) Monitoring the coastline changes in Miami.

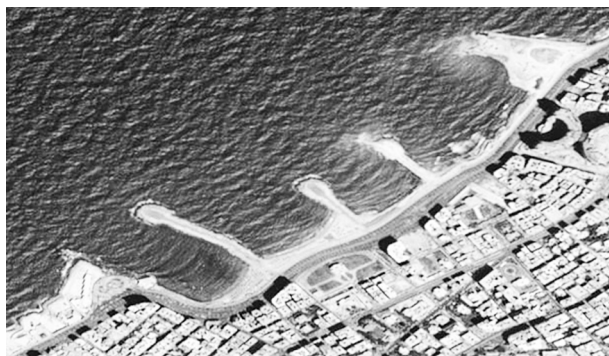
Figure 2: Some types of protection structure (El-Sharnouby and Soliman, 2011).

Shatby area has been protected by a high sea vertical wall since this area is 3-5 meter above sea water level. Small sand beach is in the lea ward of that wall. Groins having been selected for the protection of Gleem area. Miami to Montaza beach. Suffered severe erosion in 2003 storm. With time, the beach width decreased and vanished in some locations. The waves attacked

A- Satellite image for some groins in Geleem beach

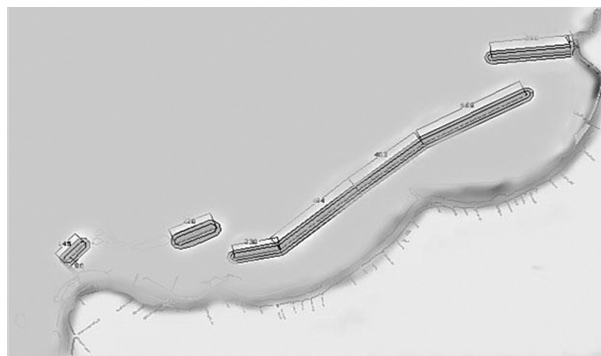
the road itself after washing all the sand In order to stabilize the eroded beach, a long, wide crest, and deep submerged breakwater has been constructed. The breakwater system consists of one main parallel breakwater and two overlapping parts (El-Sharnouby and Soliman, 2011). As shown in. Figure 2.

B- Layout of submerged breakwater were constructed between Miami and Montaza beaches

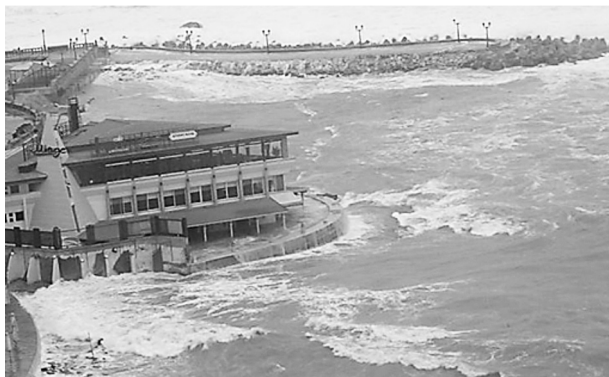
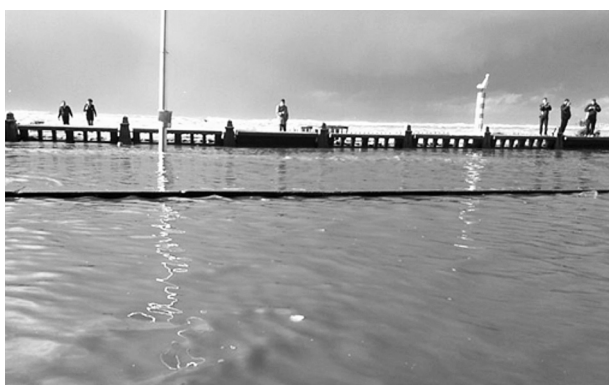
- The protection structures failure with adverse results during storm seasons such as December 2010, hit Alexandria city, and directly attacked its shoreline, Figure 3.

Figure 3: Wave flooding due the sea level rise at Alexandria coastline, 2010.
